CASE REPORT

Retrieval and Replacement of Fractured Zirconia Abutment

Othman Wali

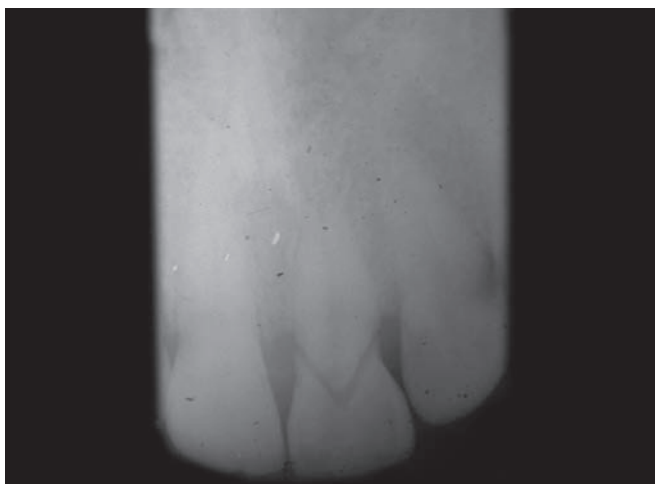
A 60-year-old male patient presented with fractured upper left central incisor cervically in a very strange way, two oblique lines meet coronally (Fig. 1). Tooth was endodontically treated and restored prosthodontically with a temporary crown. But, tooth could not withstand those treatments due to unfavorable crown root ratio (Fig. 2). So, Patient was advised to extract and replaced by implant PrimaConnex[®] Tapered Implant, TC RD 4.1 × 13 with immediate nonfunctional loading temporary crown. After 3 months, Zirconia abutment was inserted and porcelain crown with Zirconia base was cemented (Fig. 3).

Fig. 1: Two oblique line fracture in 21

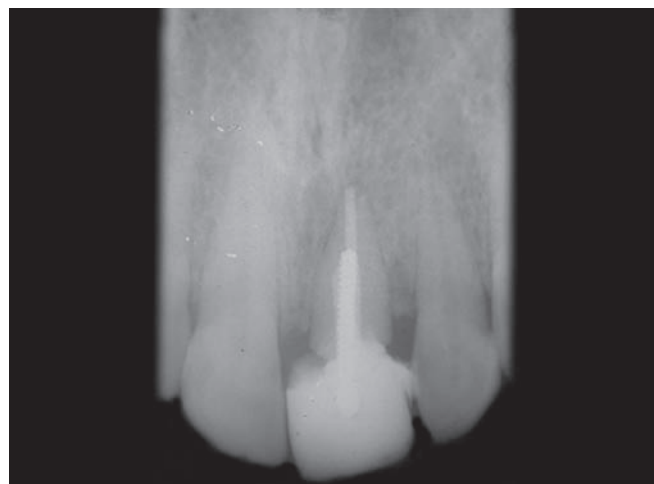
Fig. 2: Crown fracture seen in 21

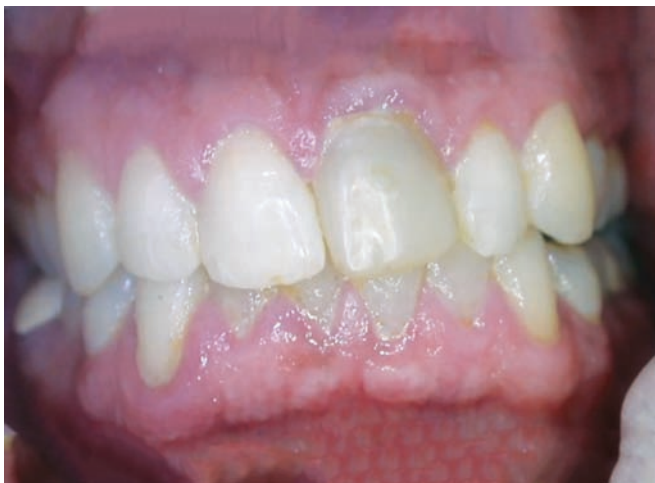
Fig. 3: Zirconia abutment with porcelain crown

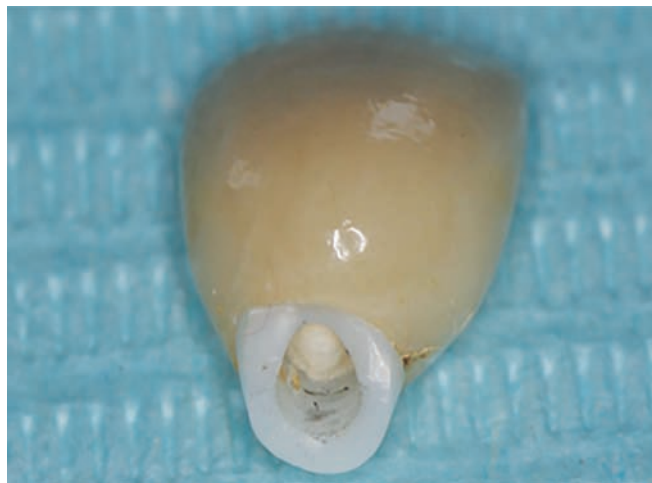
Two years later, patient came with fallen down crown for cementation. Unfortunately, He bit on very hard subject resulted in fractured Zirconia abutment close to its base. Clinical examination revealed a fractured zirconia abutment at its apical part (Fig. 4). Clinical access and visibility were compromised (Fig. 5). A radiograph was made to help determine the exact location of the fracture part (Fig. 6). Access to the abutment screw

Fig. 4: Interim prosthesis and fractured zirconia abutment

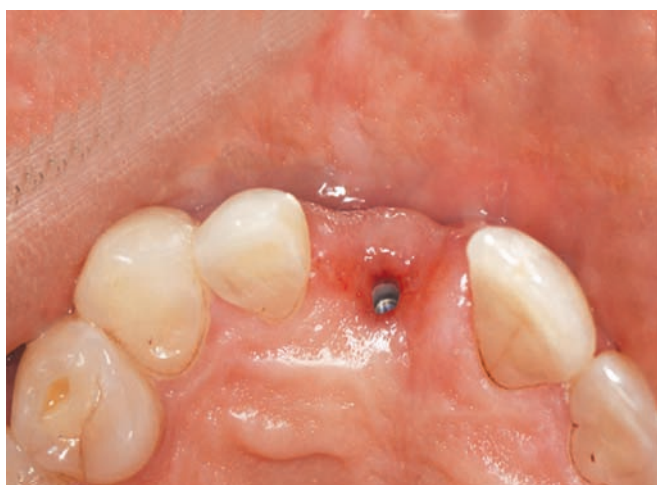
Fig. 5: Occlusal view of the fractured zirconia abutment

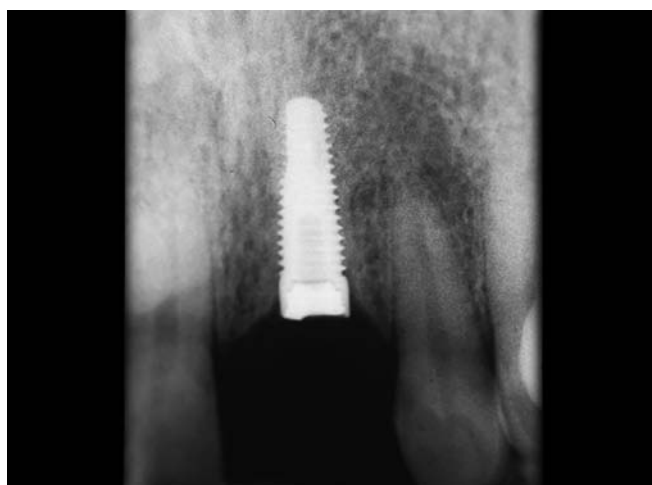
Fig. 6: Periapical radiograph displaying bone level implant and fractured zirconium abutment

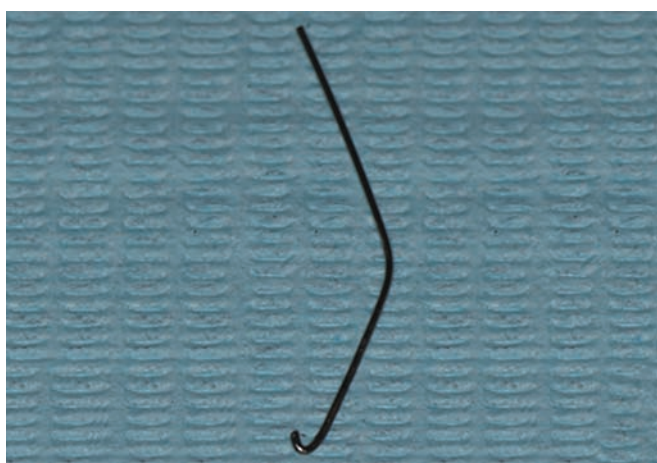
Fig. 7: Orthodontic stainless steel wire (0.016") with the hook and bend

had to be achieved to successfully loosen and remove the abutment without raising the flap. To remove the fractured abutment, orthodontic stainless steel wire (0.016") is used to engage the apical borders of abutment to remove it. Loop was made at the end of orthodontic stainless steel wire which was slightly bigger than head

of the abutment screw and also bend was given in middle third of the wire to get a better accessibility (Fig. 7). Different angulations were tried to engage the apical portion of the abutment. Efforts were made to minimize damage to the implant head.

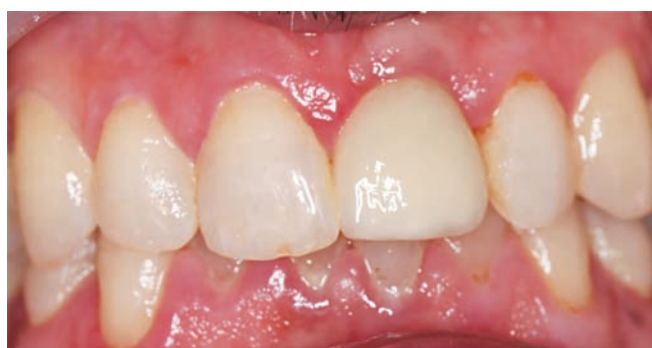
Fig. 8: New porcelain crown

New final impression and new crown has been delivered (Fig. 8). The prognosis and patient satisfaction is really high. This method is very simple and easy for routine application because this procedure is not time-consuming and involves very less risk of damaging the
